Transfer faults

IMPAX/SK has developed a special algorithm which is capable of reliably detecting rotated heads using a separate ZOOM-channel.

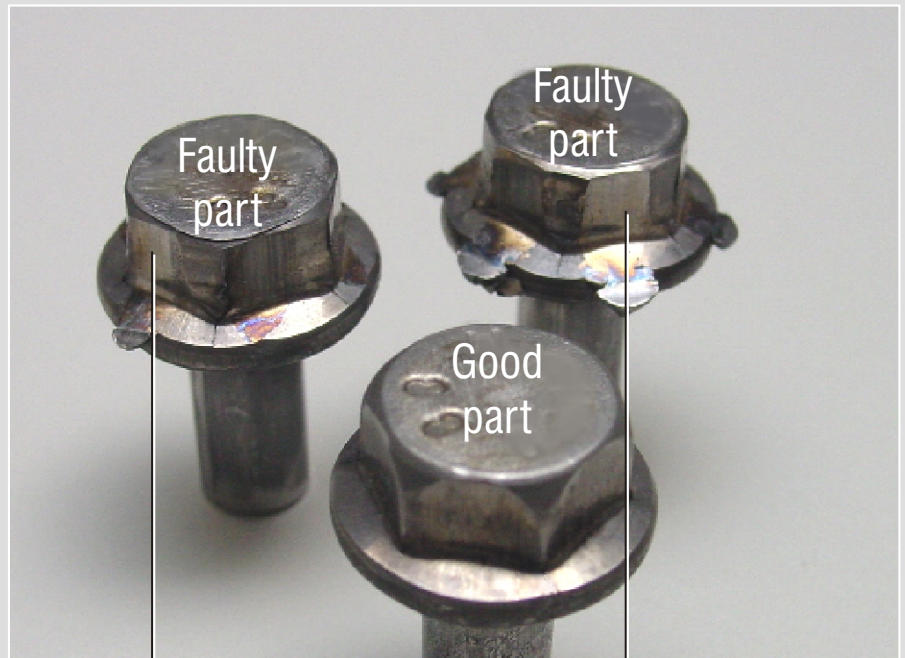
Hexagon Parts with “rotated heads”

Fault with partial rotation during transfer: partially trimmed corners

Fault with full 60° rotation during transfer: all corners sheared off

The parts tend to rotate during the transfer from one die to the next and will no longer match up with the hexagonal die pre-form. The corners of the hexagon are sheared off and remain as excess material on the external shape of the part.

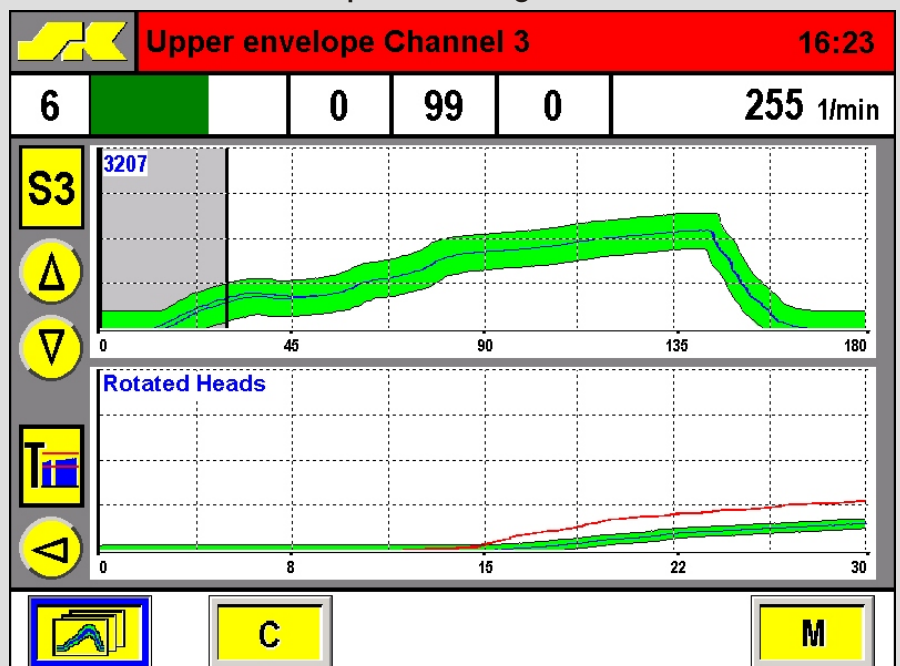
Detection of rotated parts using ZOOM

Excessive forces are detected easily by zooming into the process.
